## 32 EAST 64TH STREET New York City

# Tech Notes

## Restoring Metal Roof Cornices

Richard Pieper  
Director of Preservation  
Jan Hird Pokorny, Architects and  
Planners

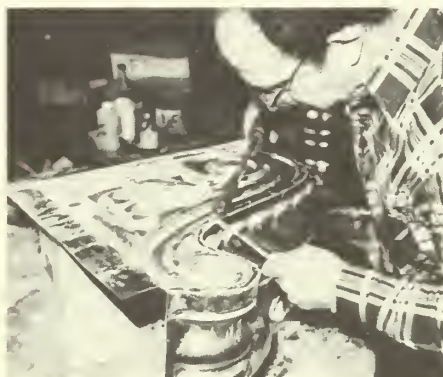
removal was dismissed because of environmental and public safety considerations and potential problems of the residue soiling the exterior masonry. Tests of water spray removal techniques showed that successful cleaning was achieved with a rotating tip spray device, which removed nearly all paint without harming the metal substrate (*see figure 7*). Care was required when spraying the zinc molding that was to remain, since the water pressure required to remove the paint was sufficient to dimple the projecting metal of the ornament. Water and paint chips were collected in troughs of sheet plastic. Paint residue was gathered to the extent possible, but the spray effluent was difficult to control and some spilled onto the building and sidewalk bridging. In some areas it was necessary to supplement water removal with light hand scraping, using a flat scraper after most paint had been removed.

A number of factors contributed to the success of the cleaning and paint removal technique. Because the cornice on this building was accessible from behind, it was possible to monitor and remove any excess water that penetrated various openings in the cornice caused by deterioration. Weep holes at the base allowed water to seep out of the cornice. For other projects where less extensive work is required and particularly where the cornice is backed with wood, other paint removal and cleaning methods may be necessary.
